# Evaluation of Road Pavement Condition Using the Pavement Condition Index (PCI) Method: A Case Study of the Taebenu Road Section in Kupang City

<sup>1</sup> Civil Engineering Study Program, Akademi Teknik Kupang, Kupang, Indonesia

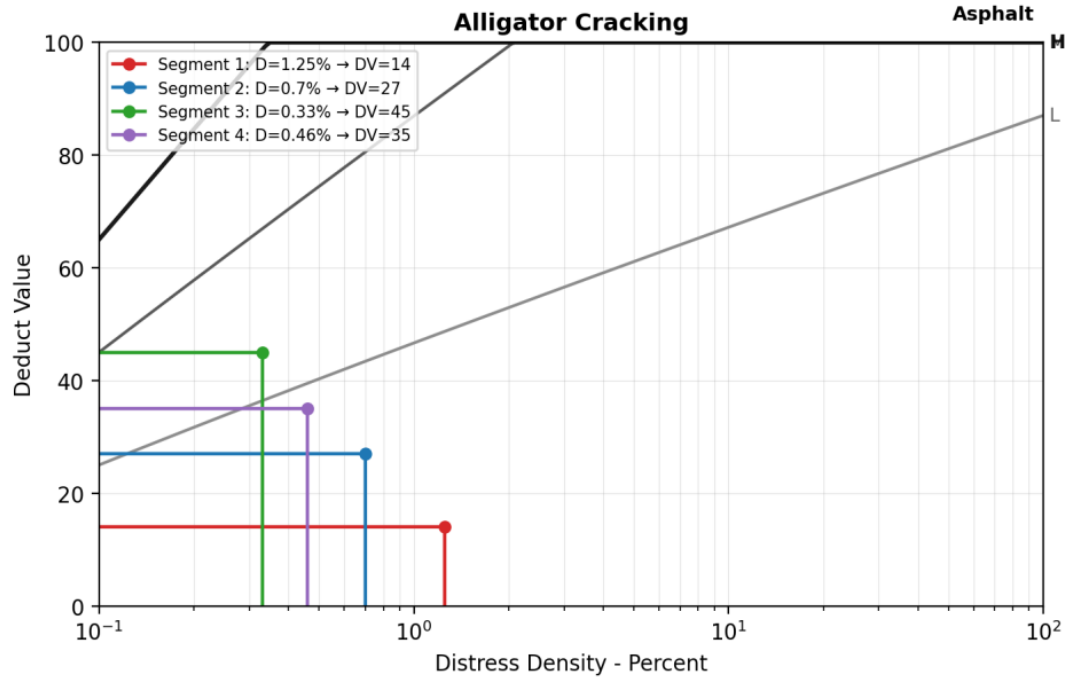
Figure 1. Deduct value curve for Alligator Cracking with density–DV reading points for each segment (Medium severity).

Figure 1 shows the DV reading for alligator cracking at Medium severity for the four segments: Segment 1 at a density of 1.25% reads DV = 14, Segment 2 at a density of 0.70% reads DV = 27, Segment 3 at a density of 0.33% reads DV = 45, and Segment 4 at a density of 0.46% reads DV = 35.

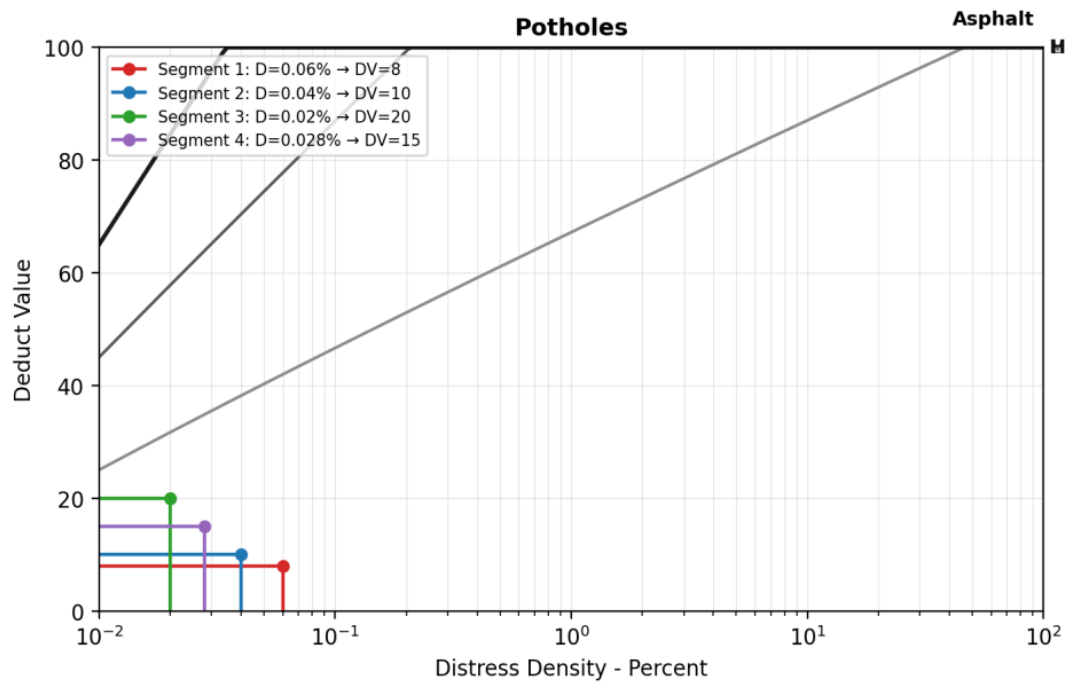
Figure 2. Deduct value curve for Potholes with density–DV reading points for each segment (High severity).

Figure 2 shows the DV reading for potholes at High severity: Segment 1 at a density of 0.060% reads DV = 8, Segment 2 at a density of 0.040% reads DV = 10, Segment 3 at a density of 0.020% reads DV = 20, and Segment 4 at a density of 0.028% reads DV = 15.

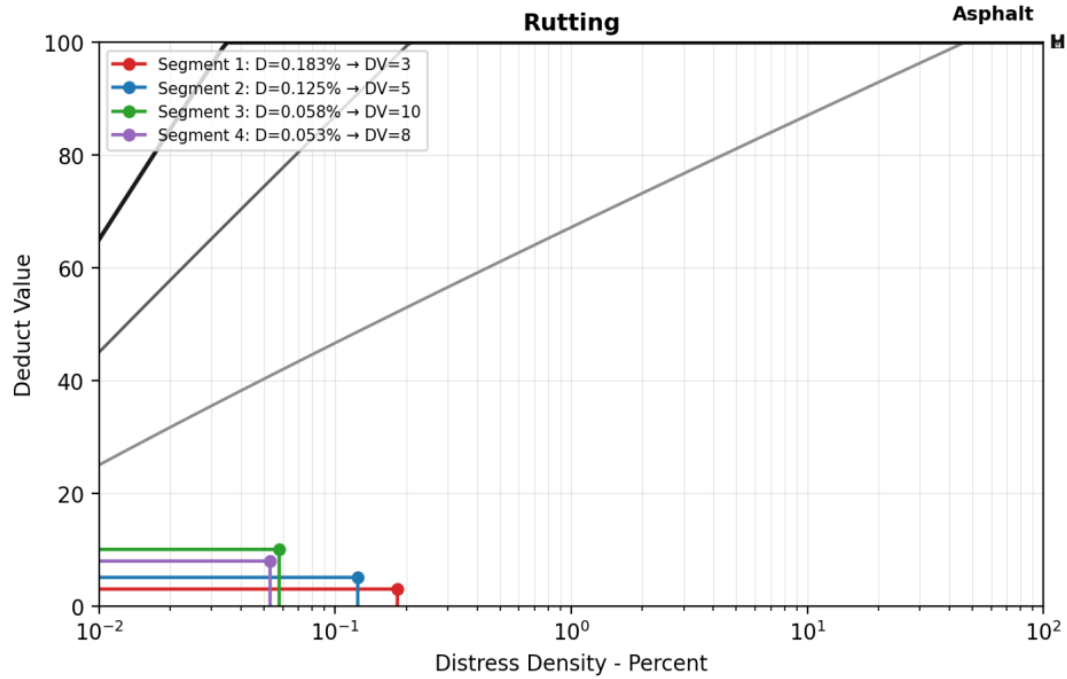
Figure 3. Deduct value curve for Rutting with density–DV reading points for each segment (Low severity).

Figure 3 shows the DV reading for rutting at Low severity: Segment 1 at a density of 0.183% reads DV = 3, Segment 2 at a density of 0.125% reads DV = 5, Segment 3 at a density of 0.058% reads DV = 10, and Segment 4 at a density of 0.053% reads DV = 8. These DV values are summed to obtain the Total Deduct Value (TDV) and subsequently corrected to obtain the Corrected Deduct Value (CDV), as presented in Table 2.

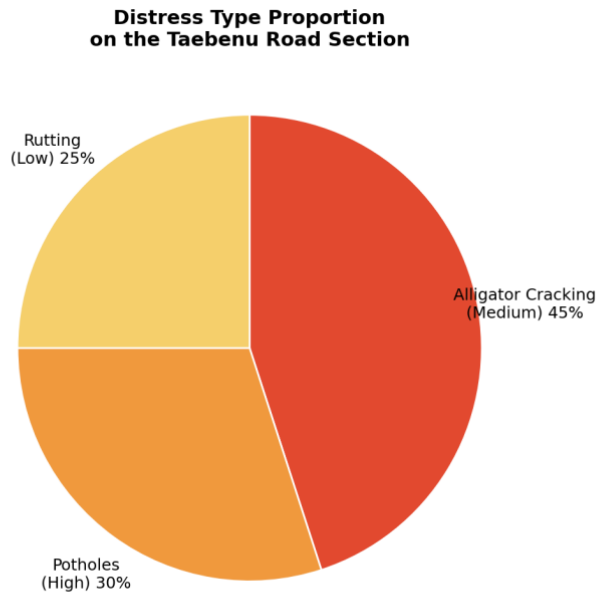
Figure 4. Proportion of distress types on the Taebenu road section based on Table 1.

Figure 4 clarifies that alligator cracking (45%) and potholes (30%) dominate the damage on the Taebenu road section, so these two distress types contribute the most to the deduct value in the subsequent calculation stage.

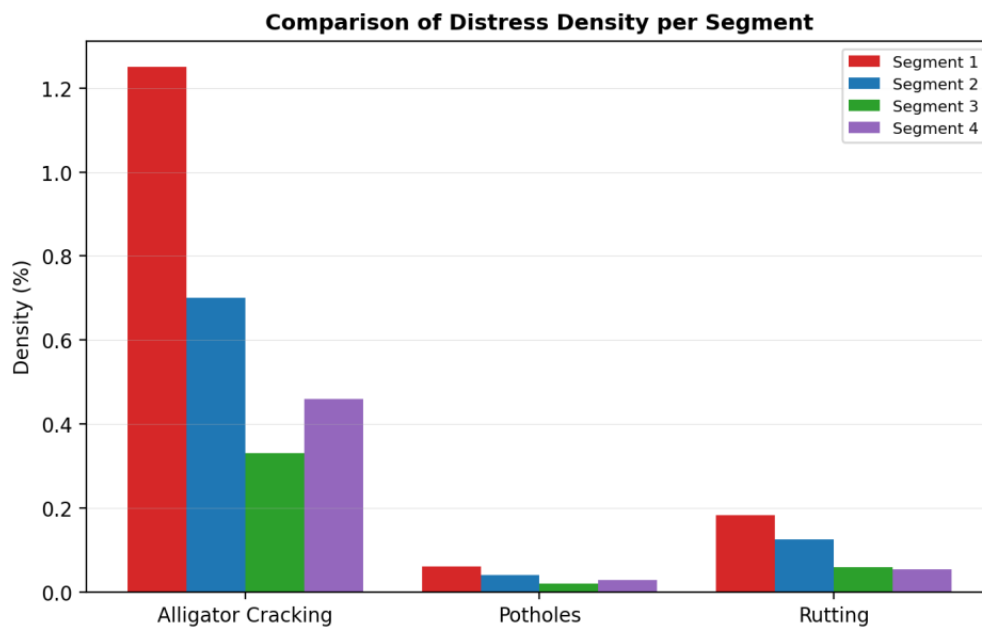
Figure 5. Comparison of density for each distress type across the four segments.

Figure 5 shows that the density of alligator cracking in Segment 1 (1.25%) is the highest among the four segments; however, because its severity level is classified as Medium, the resulting deduct value (DV=14) is smaller than Segment 3, which has a lower density (0.33%) but produces a DV of 45. This confirms that the deduct value in the PCI method is not determined solely by density, but also by the combination of distress severity level (Shahin, 1994).

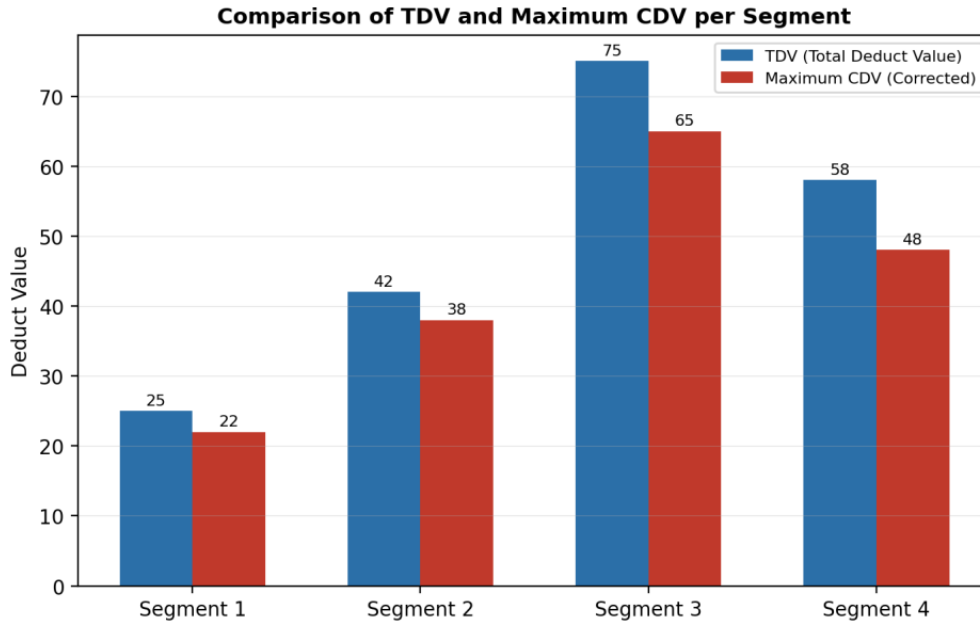
Figure 6. Comparison of TDV and maximum CDV resulting from the correction iteration for each segment.

Figure 6 shows that the CDV correction process does not always significantly reduce the TDV value; in Segments 1 and 2, the maximum CDV is actually slightly higher than the initial TDV due to the replacement of small deduct values with a value of 2 in the second iteration ( $q=2$ ). Meanwhile, in Segments 3 and 4, the maximum CDV is below the initial TDV, consistent with the purpose of the CDV correction, which is to prevent excessive reduction in the PCI value due to the large number of distress types in a single segment.

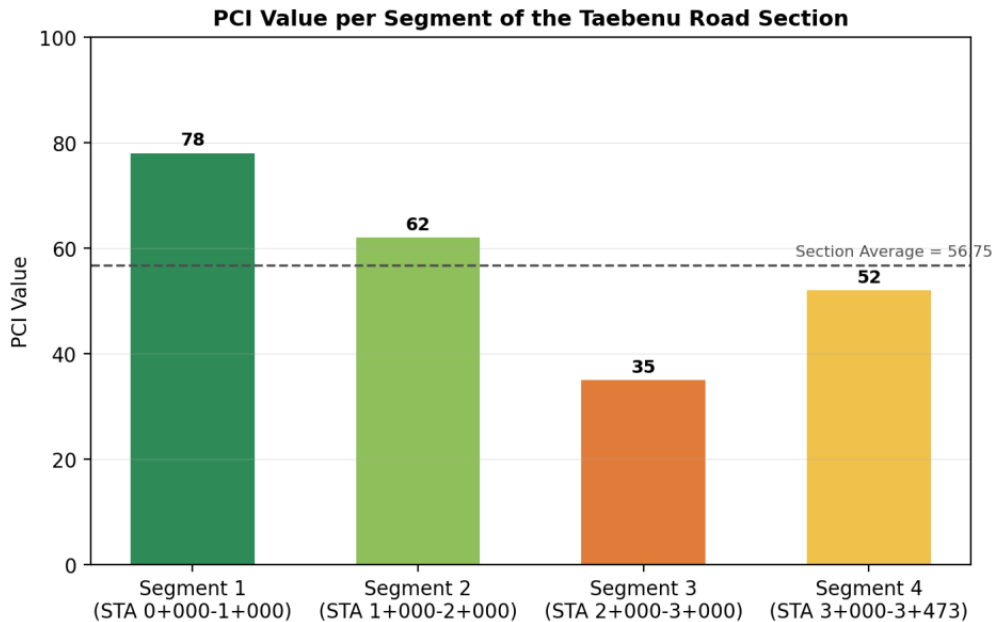
Figure 7. PCI values per segment of the Taebenu road section compared to the section average line (56.75).

Figure 7 visually shows that PCI values vary considerably between segments, from 35 (Segment 3) to 78 (Segment 1), with three of the four segments falling below the section average line. This indicates that the average value of 56.75 is somewhat more optimistic than the condition of most segments, as it is “lifted” by the much better condition of Segment 1.

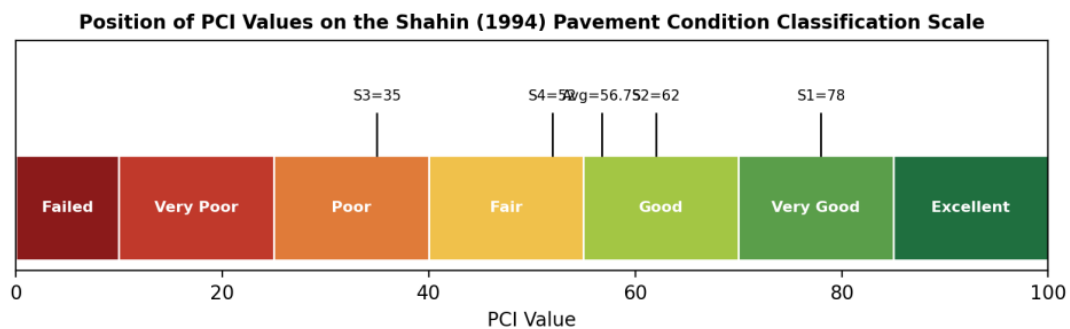
Figure 8. Position of the PCI value for each segment and the section average on the Shahin (1994) pavement condition classification scale.

Figure 8 confirms that although the section average value (56.75) falls within the Fair category, Segment 3 actually falls into the Poor category, which requires improvement/rehabilitation, while Segment 1 falls into the Very Good category. This visualization helps confirm that road maintenance decisions must be based on the PCI value per segment, not merely on the overall section average value.

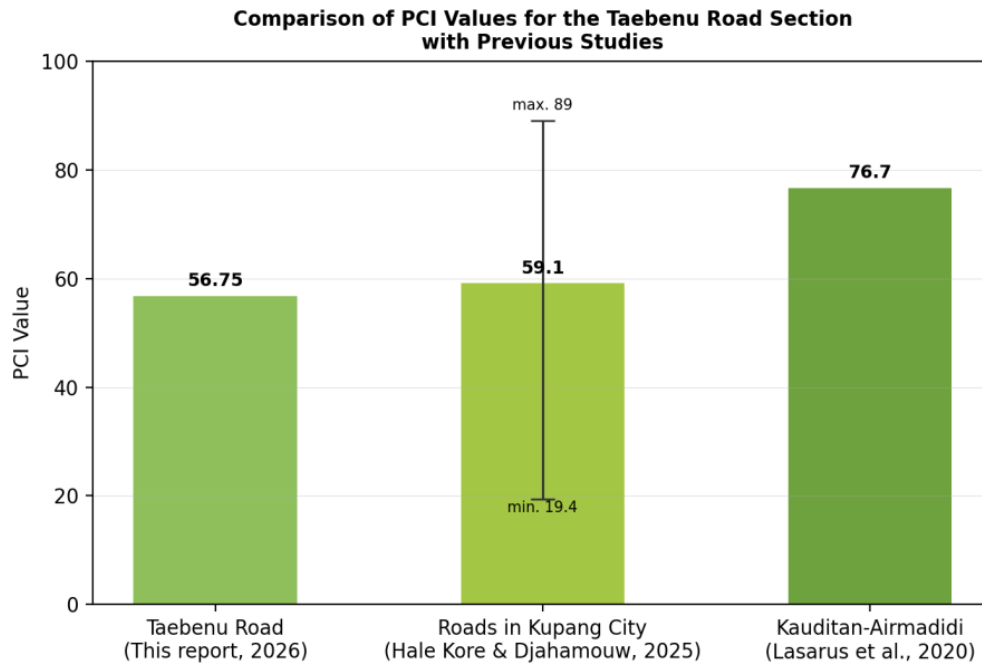
Figure 9. Comparison of PCI values for the Taebenu road section with previous studies (Hale Kore & Djahamouw, 2025; Lasarus et al., 2020).

Figure 9 shows that the average PCI value of the Taebenu road section (56.75) is just below the average of eight road sections in Kupang City in the study by Hale Kore and Djahamouw (2025) of 59.1, but still falls within the variation range of those sections (19.4–89). Meanwhile, the much higher PCI value of the Kauditan–Airmadidi section (76.7) indicates that the lower PCI value on the Taebenu road section is more appropriately attributed to hilly topography and suboptimal local drainage systems, rather than solely to heavy traffic loading.
